ARCH BEAMS

Pose A Real Danger To Workers

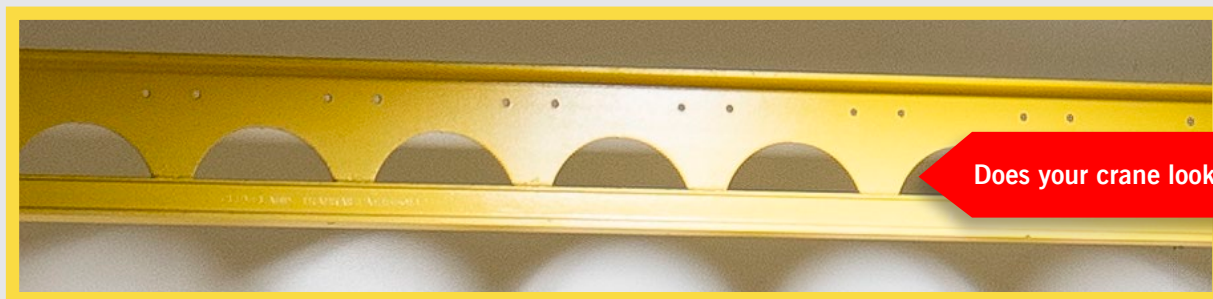
The welds in Arch Beam can weaken over time and experience Martensitic Failure, resulting in the bottom rail peeling away from the web plate. This safety issue should be brought to the attention of management immediately.
