Gorbels® Work Station Crane Increases Productivity for Glass Mirror Manufacturer

The Solution:
A Gorbels® Ceiling Mounted Work Station Crane

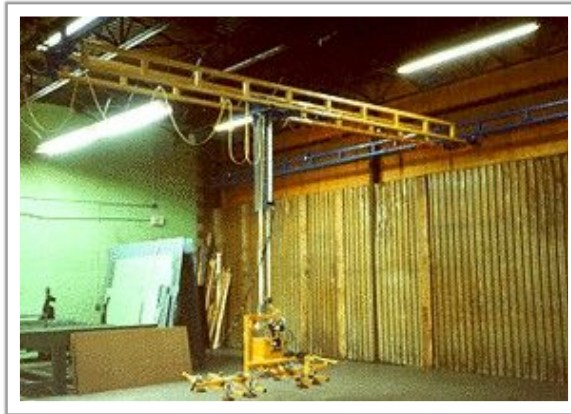
A glass mirror manufacturer makes large mirrors for the furniture industry. In the packaging process of these mirrors, the large, heavy (up to 300 lbs.) sheets of glass must be lifted off a conveyor, tilted 90 degrees, and then placed in a wooden shipping crate. To keep the fabrication process running efficiently, one mirror must be lifted and placed in the crate every 60 seconds.

Before the Gorbels® system was installed with the vacuum lifter, it took four people to lift, tilt, and position these mirrors in the crates. Doing this activity by hand was a problem for many reasons:

- Improved Safety: manual lifting eliminated
- Ease of Movement and Positioning: every employee could now perform the task
- Productivity improvements: the operation could now be performed by two people
- Cost: The Gorbels® system was 3X less than the automated system
